Engineering With Nature

Alternative Techniques to Riprap Bank Stabilization

FEMA

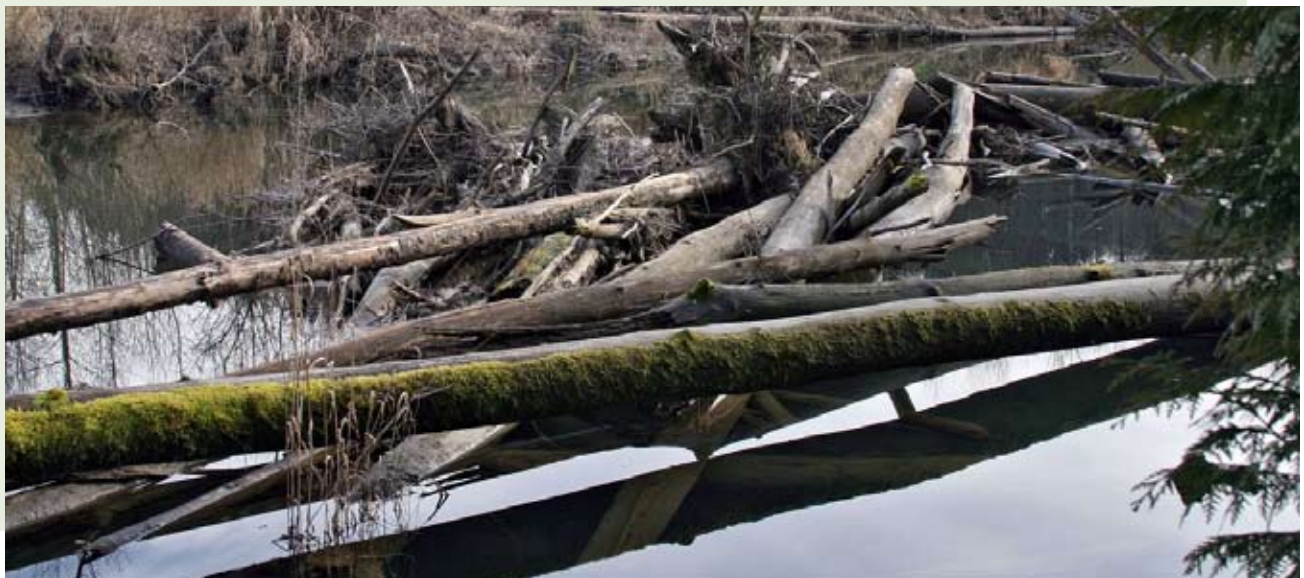
During flooding additional woody debris is recruited by the original logs.

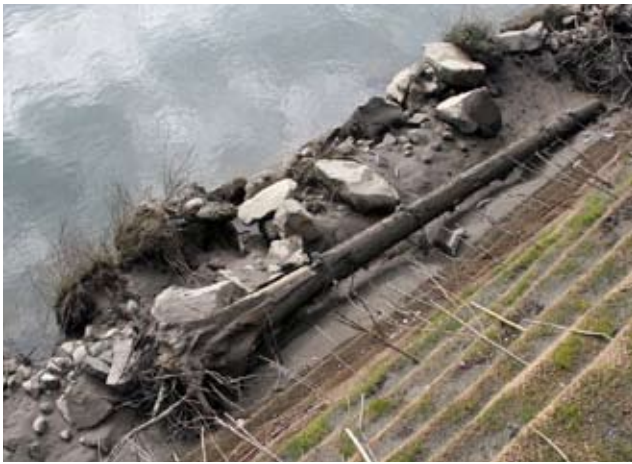
The willow cuttings planted throughout the embankment lend root cohesion and stability to the structural earth wall.

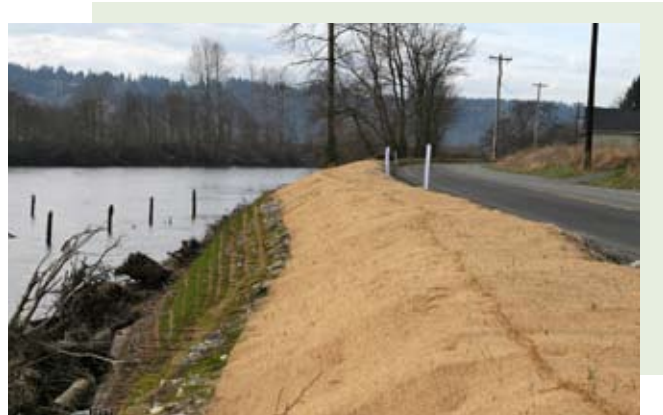
Eventually the coir fabric and the structural earth wall itself will be completely overgrown with hydro-seeded grass and other vegetation.

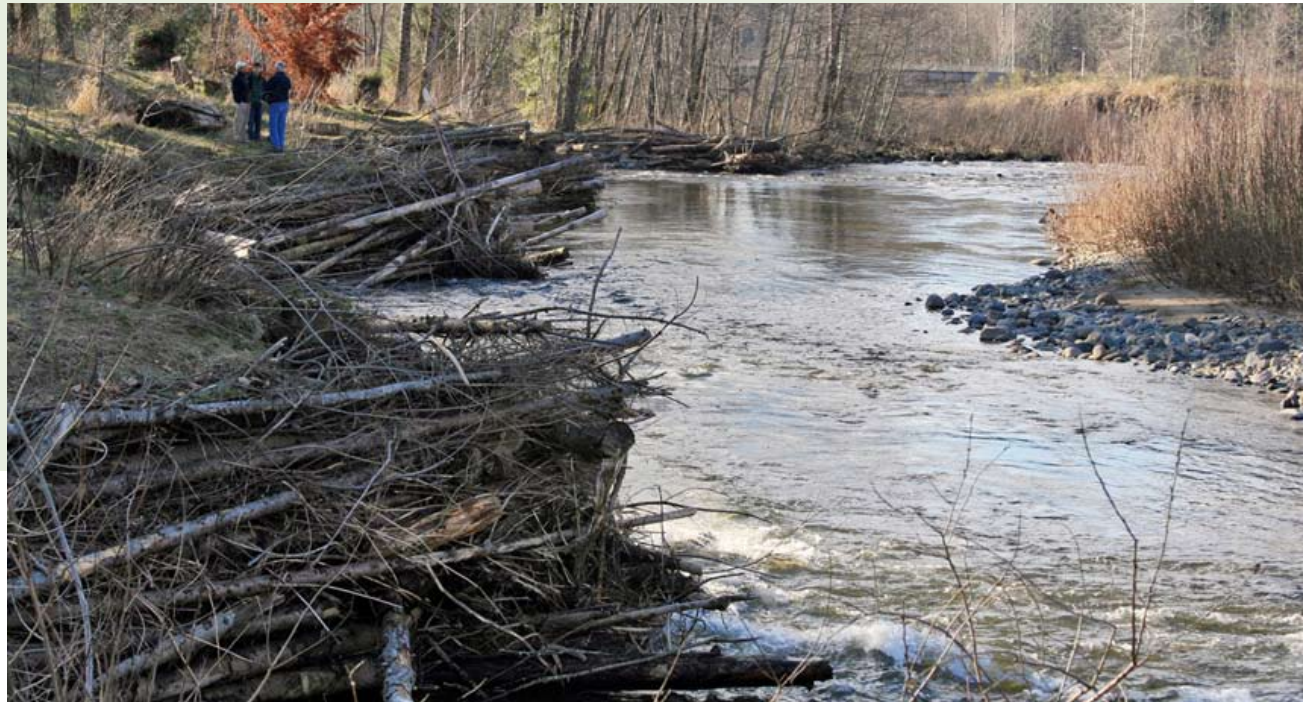
Four of the engineered logjams designed by Herrera Environmental Consultants on the Mashel River outside of Eatonville, WA.

The logs comprising the base of the logjam structures are driven deep into the riverbank, some as much as 15-30 feet in depth. A criss-crossed pattern of logs forms the core, which is likened to that of an eleva-

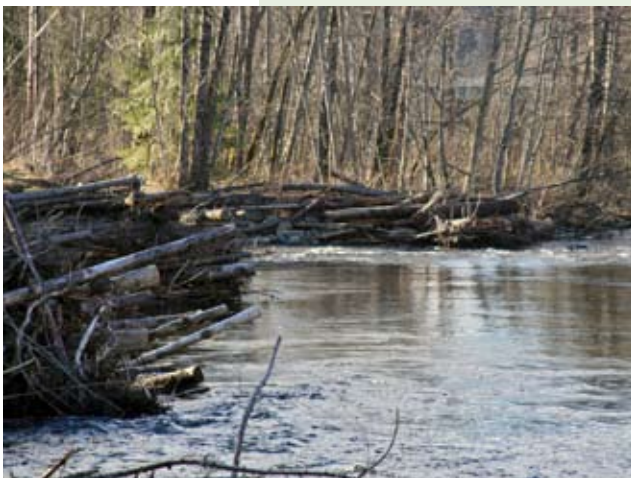
The complexity added by the logjams is important for slowing down water flow on the river.

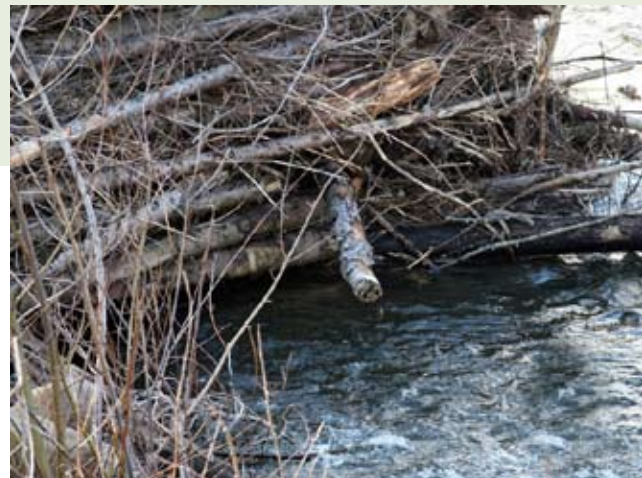
The pools established behind each jam provide much needed habitat and refuge for migrating fish.

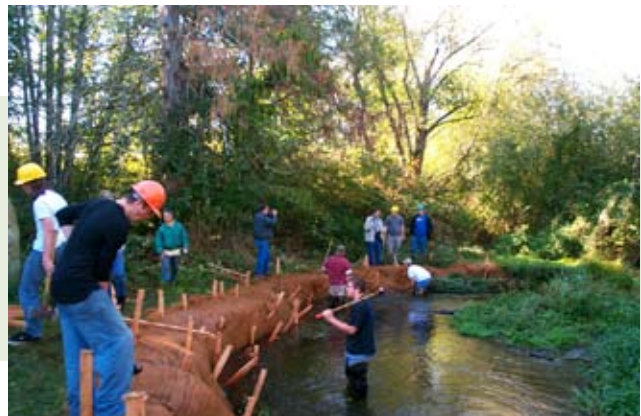
Construction of the brush mattress underway.

Geiger's solution was to design a brush mattress along 77 feet of the creek. The mattress was built by tying 6-foot long Douglas fir and Grand fir tree tops to 4-foot long, 2-inch by 2-inch cedar stakes, driven in a 1-foot by 2-foot pattern into the stream bank. The tree tops are placed with the butt upstream, with each piece tied to at least three separate stakes, and shingled so the upstream tree overlaps two-thirds

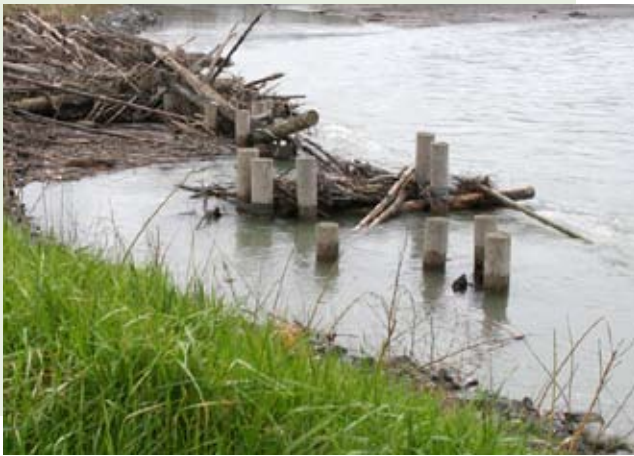
One of the scour holes being stabilized by the Overflow project. Woody debris has begun to collect and will be incorporated into the riverbank.

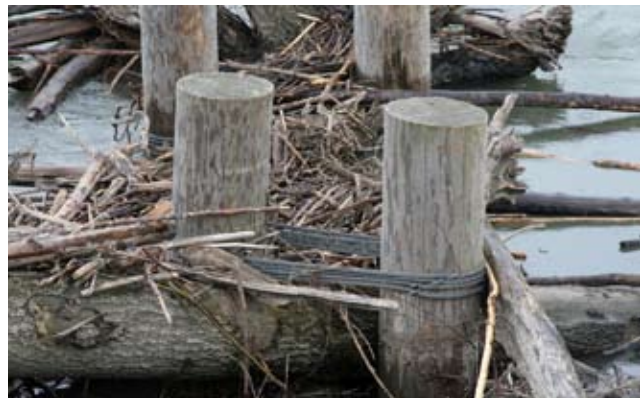
The timber piling structures capture woody debris, which provides roughness to the river, and ultimately establishes additional habitat.

“In terms of the bank stabilization project, the timber pilings are a stand-alone component,” said Lee. “This means that if some of the timber piling structures are damaged, the integrity of the entire bank stabilization design is not compromised. At the same time, there are bank stability benefits provided by these structures. They provide an incredible amount of roughness along the portions of the riverbank where they are located. This slows the water along the bank behind them, promoting deposition and the establishment of vegetation, which helps to further stabilize these areas.”

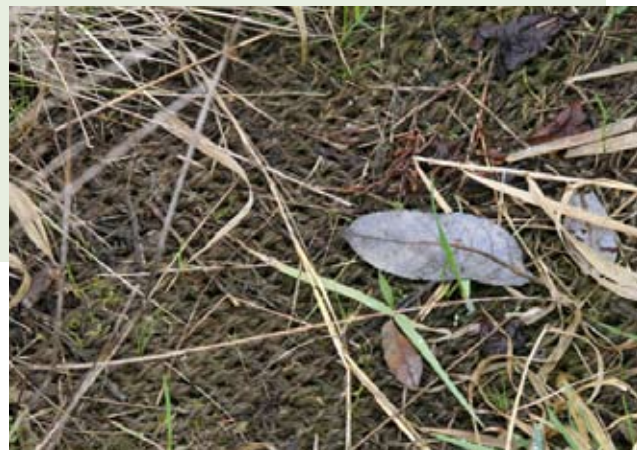
Coir fabric covers the upper bank.

“Using three-quarter-inch plywood that was eight feet long and 12 inches high, we built forms to aid in the construction of over a couple miles of soil lifts,” said James Lee. “Basically, we laid down the coir fabric, planted the willow cuttings, and placed the dirt. The wooden form provided something for the dirt to push up against as you ran over it with the walk-behind compactor. Otherwise, if you just simply had coir fabric holding back the soil when you put the compactor on it, the fabric would bulge out and likely rupture. The forms allowed us to build the soil lifts in a uniform manner. As the crews got proficient, we started to make excellent production numbers per day. It really worked well.”

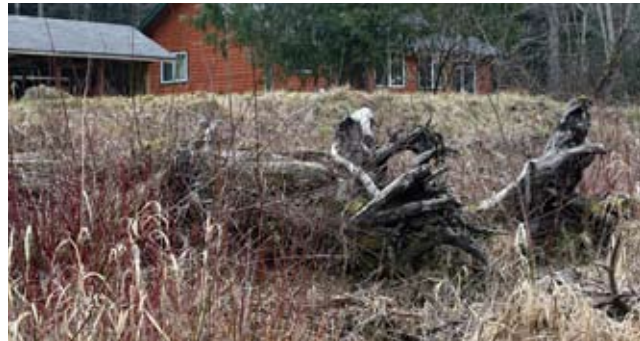
Downed trees claimed by the Forest Service provide the skeleton for the rock groin structure.

The first step in installing the groins involved temporarily blocking the river from entering the construction site. Since the project was undertaken while the river was at a seasonally reduced level, only a small area had to be coffered off with sandbags. Once the construction site was secured, three trenches extending 25 feet back into the bank were dug, and tapered down into the river channel. Multi-sized rocks similar to that used in riprap design were then carefully layered into the trenches.

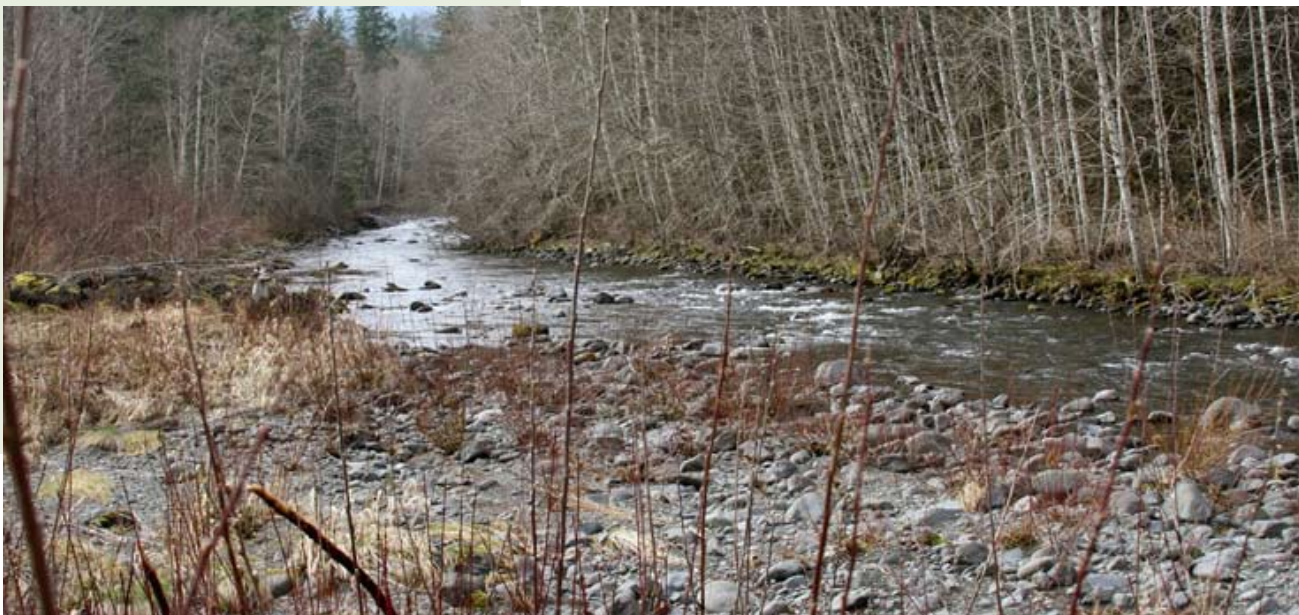
Planted willows, dogwoods, conifers and other trees will create a mat of roots to help stabilize the riverbank.

“We planted a lot of willow in there,” said Latham. “Along with red ochre dogwood, alder, some conifers, as well as Douglas firs and cedars. By the time the logs decay, which is a long way off, there will be such a mat of roots from the vegetation that it’s going to make the banks really stable.”

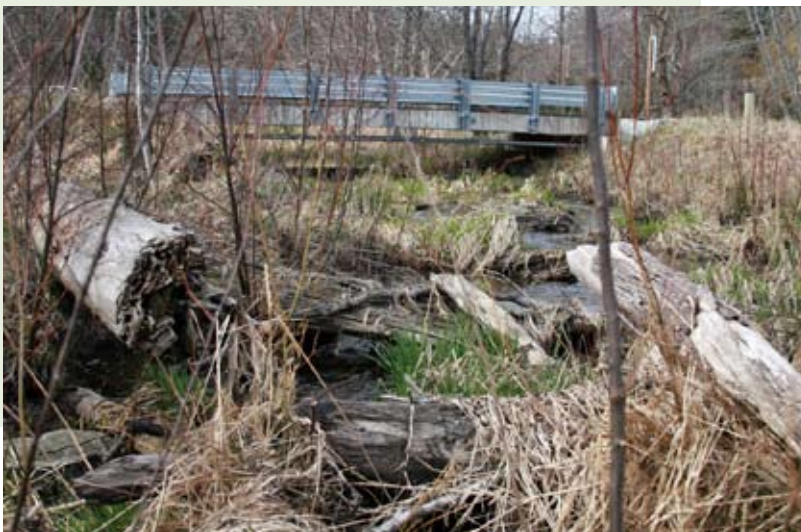
Wood positioned downstream of the bridge slows water flow and provides habitat for fish and other wildlife.

Another portion of the bank stabilization and habitat complexity involved the addition of wood in the creek immediately past the bridge, as well as further downstream. The wood establishes important habitat for fish traversing the stream, and causes flow to slow down considerably during periods of high water, further adding to the protection against erosion.

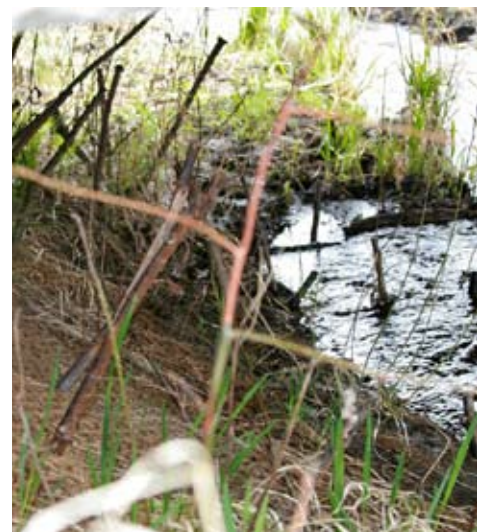
Coir matting and planted vegetation stabilize the creek banks under the bridge.

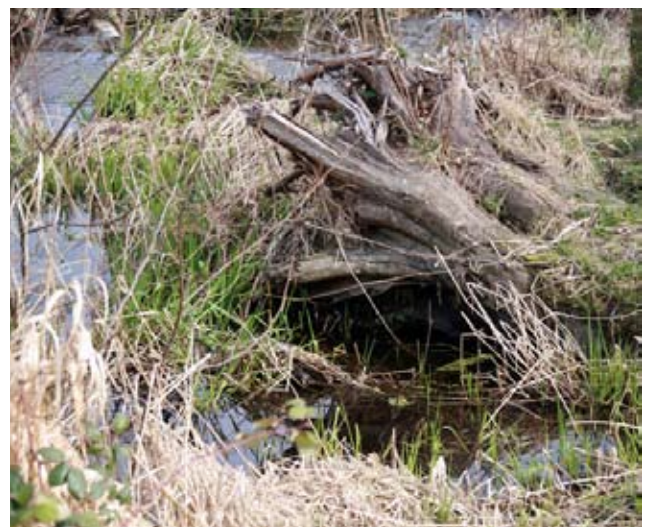
Many of the logs are actually buried in the banks.

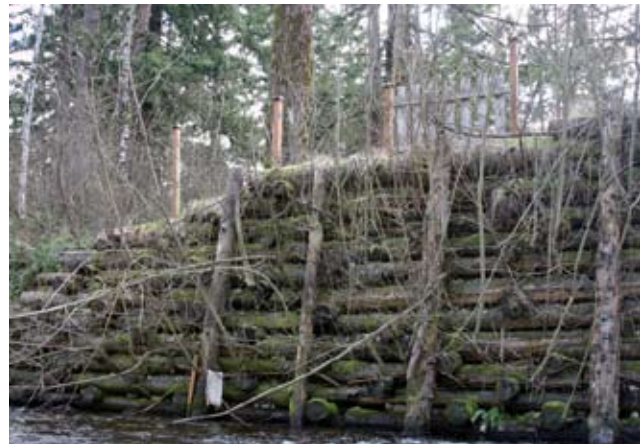
The crib wall will overgrow with vegetation, which will ultimately become the structure itself when the logs finally decay.

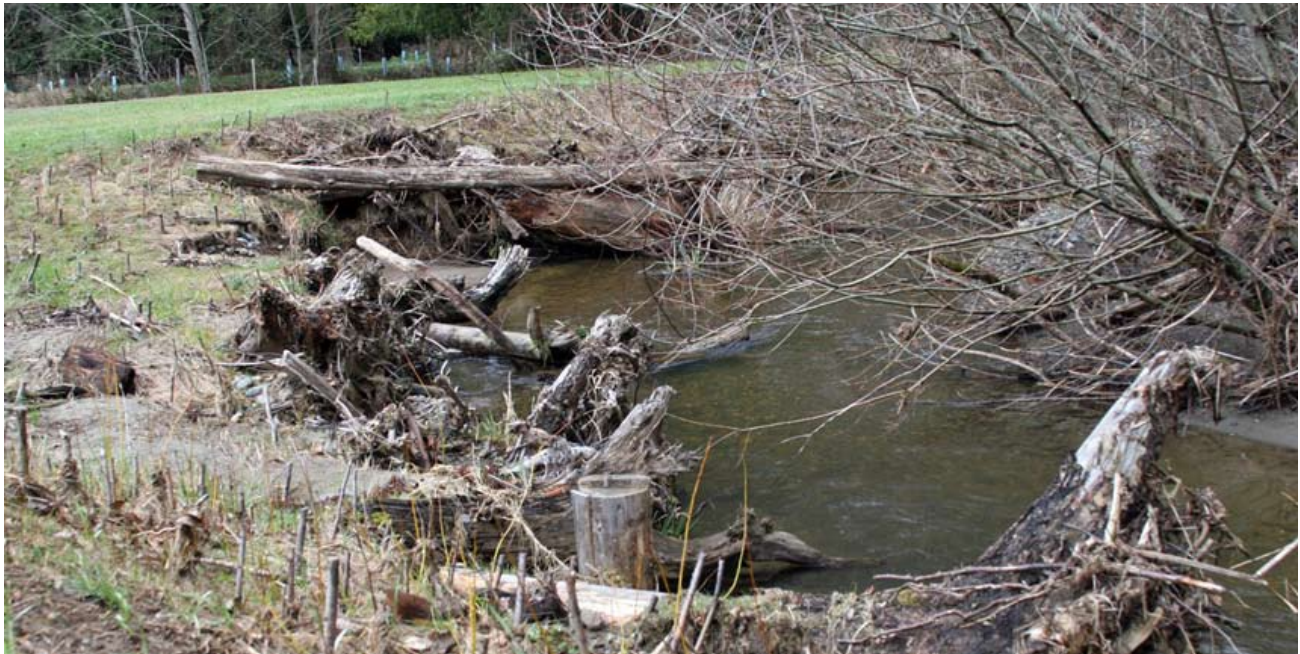
Wood added to the banks of Schneider Creek slows water flow and improves habitat diversity.

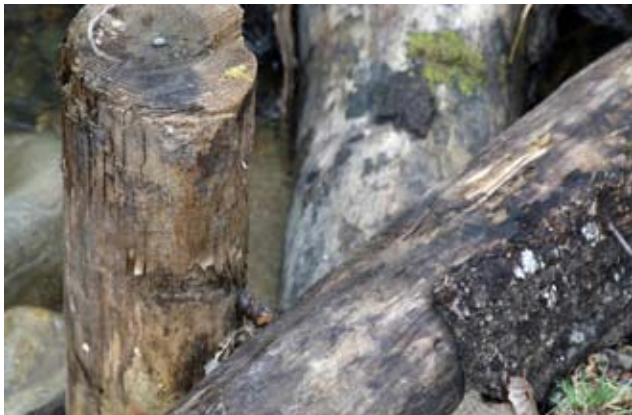
The logs in the jams are secured to each other with rebar.
